Artificial lightning testing on graphite/epoxy composite laminate

Yoshiyasu Hirano^{a,*}, Shingo Katsumata^b, Yutaka Iwahori^a, Akira Todoroki^c

^aJapan Aerospace Exploration Agency (JAXA), Advanced Composite Group, Aerospace Research and Development Directorate, 6-13-1, Ohsawa, Mitaka-shi, Tokyo 181-0015, Japan

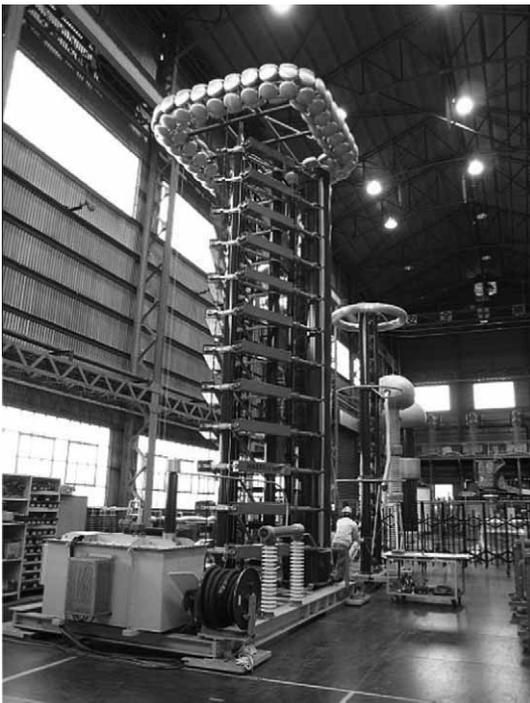
Fig. 1. Modified impulse voltage generator (IVG) produced by Haefely test AG.

In order to simulate lightning strikes, an impulse high-voltage generator (IVG) produced by Haefely test AG (see Fig. 1) and an impulse high-current generator (ICG) produced by Nisshin Electric Co. (Fig. 2) were used in this study. The IVG can generate an impulse current with high maximum current but only for a short time. On the other hand, the ICG can generate a long-term impulse current but with low maximum current amplitude. The IVG is equipment for generating high voltage impulse in nature. However, in this study, the wiring pattern of capacitance was modified to generating high-current impulse as with ICG. Therefore, the most suitable generator was selected according to each test condition. Fig. 3 schematically shows the cursory circuit of the generators, where R_s and R_o are resistances and C_s is capacitance. By varying R_s , R_o , and C_s , an arbitrary waveform can be generated. Here, for the ICG, R_o is always set as zero. A DC current transformer (DCCT) was connected to the ground wire from the specimen, and the waveform of the applied impulse current was measured using an oscilloscope. A detailed description of the lightning test equipment and setup used can be found in [12].

According to the test conditions listed in Table 1, artificial lightning tests were performed on 40 specimens. Conditions I–VI were tested using the IVG (Fig. 1), and conditions VII and VIII were tested using the ICG (Fig. 2). The typical measured electrical current

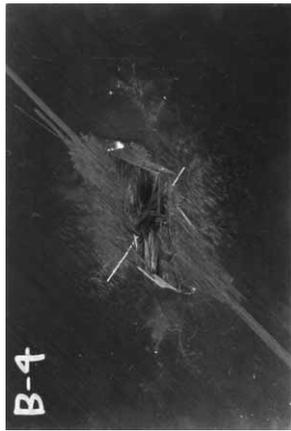
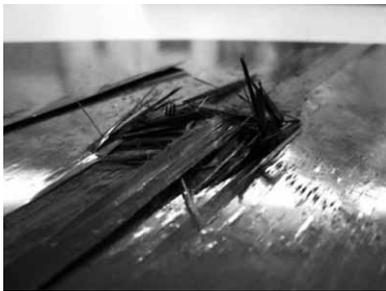
(a) Overhead view of damaged specimen

(b) Magnified view of lightning attachment point

(c) Resin deterioration area obtained by image binarization

Fig. 8. Specimen after artificial lightning strike (condition IV: 4/20 μ s, 40 kA, $t = 4.7$ mm).

The visual appearance of the tested specimen is shown in Fig. 7a–h. Each figure represents overhead view of the typical result of the specific test condition. Here, the test result with condition IV (4/20 μ s with peak current of 40.0 kA) is shown in Fig. 8 as a typical result of an artificial lightning test. Fig. 8a shows the overhead view, and Fig. 8b shows a magnified view of lightning strike attachment point. Through visual inspection, two typical damage modes can be observed. At the lightning attachment point, carbon fiber breakage can be observed several layers deep from the lightning attachment surface; fiber dissipation and resin vaporization can also be observed in a region roughly 20 mm in diameter. (This damaged region is referred to hereafter as fiber damaged area.) At the same time, a strip-shaped ply-lift in the fiber direction of the outermost 45° layer is observed. The ply-lift initiation point is the lightning attachment point, and the width is almost the same as the diameter of the fiber damaged area. Outside the surface fiber damage region, resin deteriorated area where has fuliginous and blistered surface can be observed (see Fig. 8b). In this study, this region of deterioration is referred to as the resin deterioration area. Since the resin deterioration area has the different reflectance from the intact surface, damaged region can be determined by means of an image processing. First, overhead view of post-lightning specimen is converted into grayscale image data. Then, the image is binarized using histogram information of the image data. A typical image binarization result is shown in Fig. 8c as an example. Here, the pretreatment image is Fig. 8a. The black region represents the resin deterioration area obtained by image processing.
